United States General Accounting Office

# BORDER PATROL

## Procurement of MD 600N Helicopters Should Be Reassessed

GAO/GGD-00-201

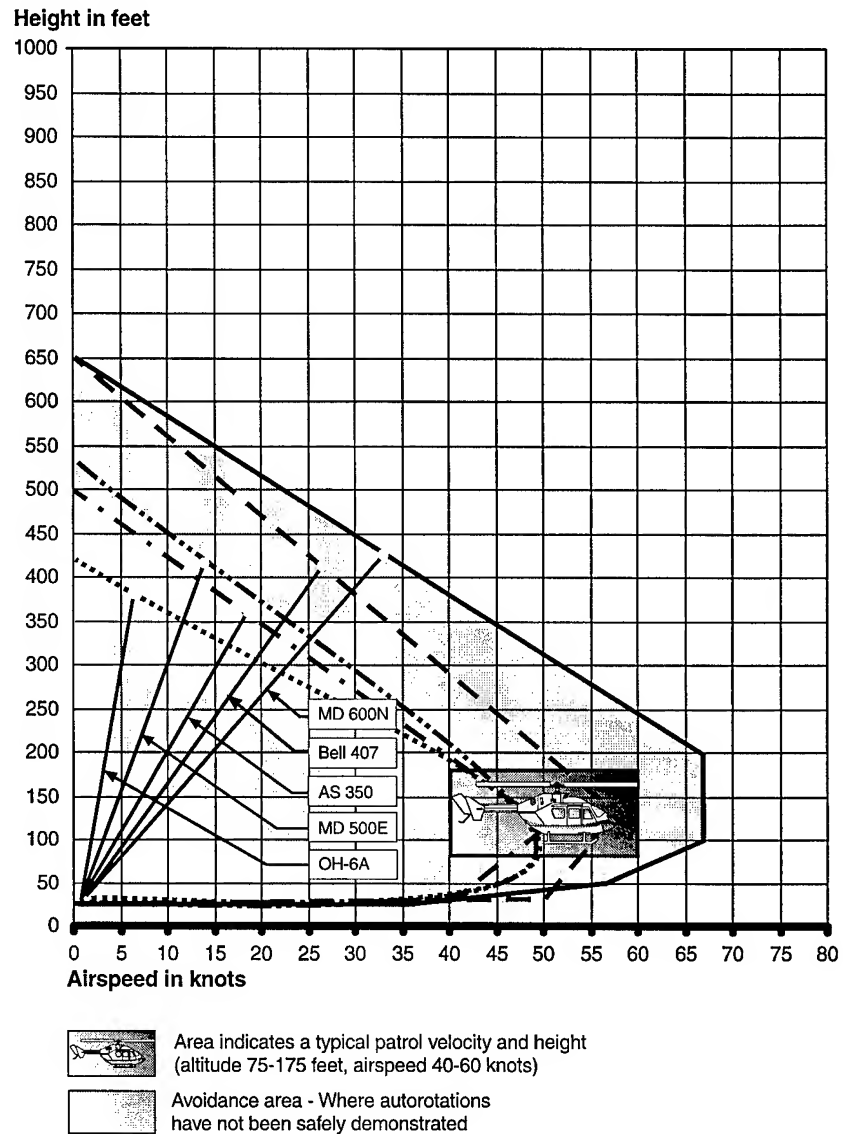
**Figure 3: Height/Velocity Curves for MD 500E, MD 600N, Bell 407, American Eurocopter AS 350, and Hughes OH-6A**

Most of the pilots we interviewed believed that the autorotation characteristics of the MD 600N are inappropriate for much of the flying performed during Border Patrol air operations missions. Autorotation is a pilot-recovery maneuver performed in the event of an engine failure that keeps the main rotor blades moving so that the aircraft descent can be controlled. Aircraft height and airspeed factors to be avoided during autorotation are depicted as a height/velocity curve.<sup>8</sup> Pilots are instructed

MDH officials stated that the pilots based their concerns on a misunderstanding of the height/velocity curve rather than on the helicopter's operational characteristics. According to MDH, the MD 600N's height/velocity curve appears to cover more area because of more stringent testing conditions used for establishing the curve.<sup>9</sup> However, we examined the height/velocity curves for several helicopters that were tested at or estimated for sea level. The MD 600N height/velocity curve had a larger area to avoid (see fig. 3). A senior FAA certification official said that this is a valid means for showing how different aircraft height/velocity curves relate to the height and airspeed of a typical Border Patrol mission.

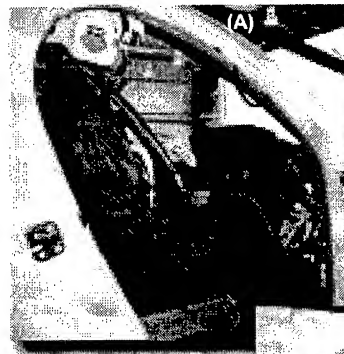
Figure 4: MD 600N Ergonomics

In addition to the heavy controls, some pilots said that the MD 600N is so uncomfortable that it affects their ability to do their work. The pilots said that after 2 hours, they must stop for a break; and several said that they suffered from pain in their knees, back, and buttocks caused by uncomfortable seats. Some pilots reported using cushions provided by Air Operations headquarters or their own cushions to relieve some of the discomfort. Several pilots also said that visibility is limited because of the door frames, particularly while using the cushions. They reported that they must get in awkward positions to look at objects below or behind them.

(A) Pilots explained that visibility is limited by the door frames, and that awkward positions are sometimes necessary to see objects below or behind them.

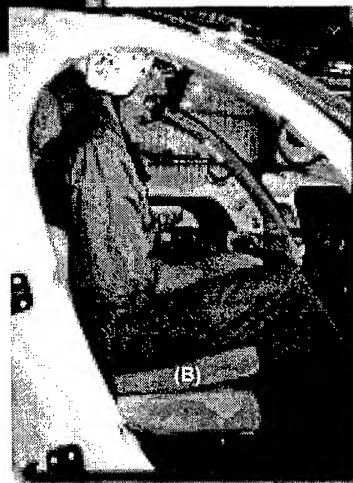
(B) Some pilots reported using seat cushions provided by Air Operations headquarters or their own cushions to relieve some of the discomfort caused by the seats in the MD 600N.

Air Operations officials agreed that the seats in the MD 600N are uncomfortable. Pilots had said they wanted padded seats, so the officials said they asked for high-quality seats during the procurement.<sup>17</sup> Air Operations officials recently took action to replace the seats provided under the original procurement. Seats tested by Border Patrol pilots during the flight evaluations for the stability augmentation system have been ordered and are being manufactured, as of September 21, 2000, according to INS.

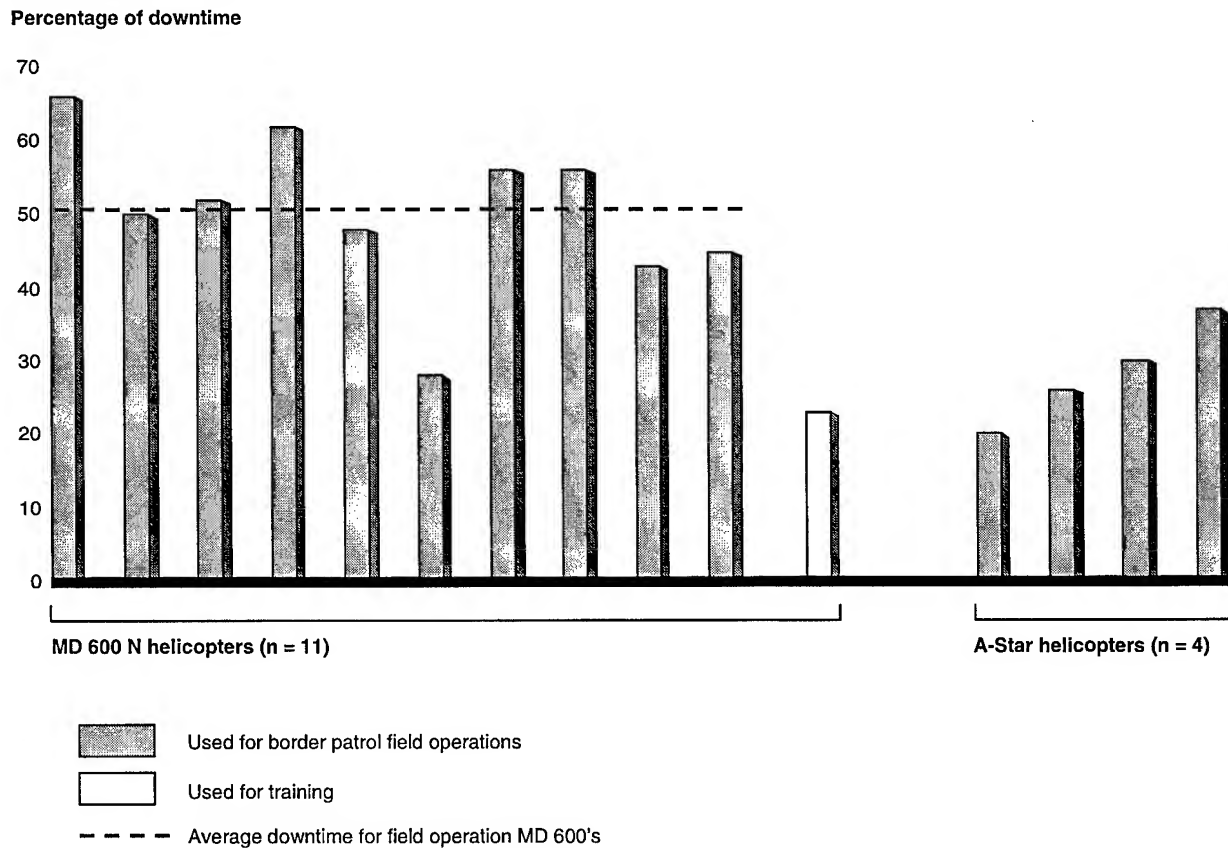
**Figure 5: Downtime for Border Patrol 600N Helicopters**

A major concern of most sector chiefs and their staffs was the significant amount of time in which the MD 600N helicopters were unavailable for use or "down." Air Operations records for December 1998 to March 2000 show that the 10 MD 600Ns assigned to Border Patrol field operations were unavailable, on average, over 50 percent of the time.<sup>18</sup> This downtime included any time that the helicopters were not operational due to avionics repair, maintenance, or while waiting for parts. In comparison, the four Border Patrol Eurocopter "A-Star" helicopters were down 28 percent of the time during the same period. Reasons for the downtime included delays in obtaining an engine repair contract, slow manufacturer approval for modifications, and parts availability.

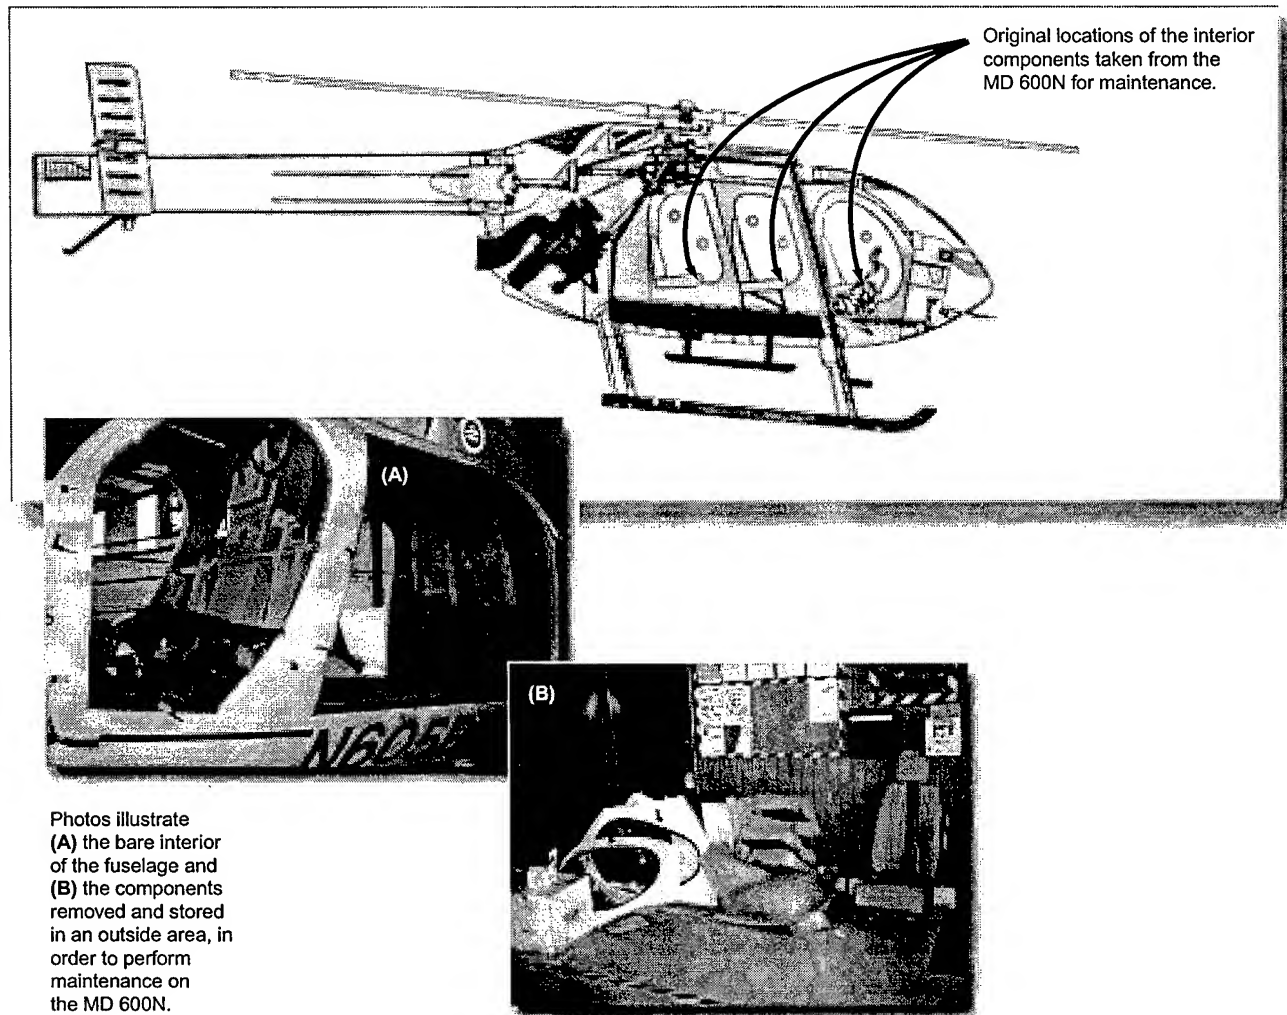
**Figure 6: Aircraft Repairs Often Require Interior to Be Removed**

Finally, mechanics in two sectors said that the design of the helicopter makes working on it time consuming because many repairs require that the aircraft be taken apart. One mechanic stated, for example, that often carpet must be pulled up, seats removed, and the interior vinyl removed in order for mechanics to access the aircraft's parts for a 100-hour inspection. Helicopters by other manufacturers, such as Bell, have their transmissions and drive trains located externally and would not need to have the interiors removed for a routine inspection, he said. The interiors have also experienced unusually high levels of wear and tear because of the need to remove them, one mechanic said.
